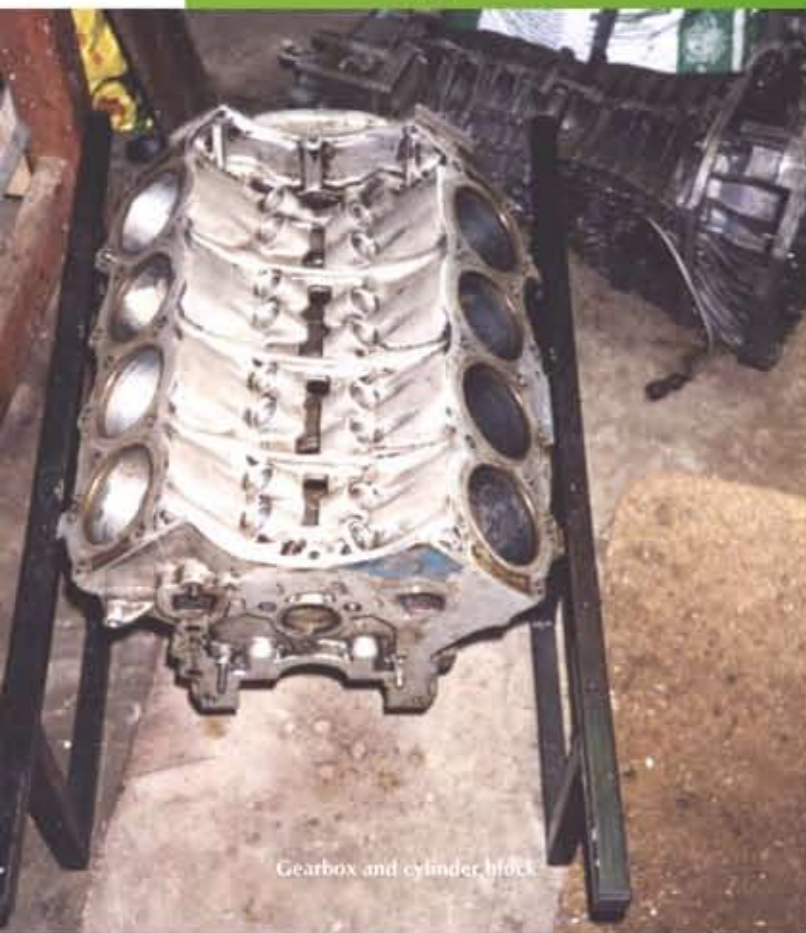
Gearbox and cylinder block

With most of the sheet metalwork completed, it was the turn of the Rover engine to receive some tender loving care. It was given to me some years earlier by a friend, as it was surplus to requirements, he having just built a new motor. It had lived in our garden under cover, and from time to time was useful for the taking of measurements. Apart from much time cleaning the cylinder block and the various parts to be reused, it was a routine rebuild to a standard Rover specification, with the exception of fitting a high volume oil pump and an updated camshaft timing chain.

Now quite presentable, it was promoted to live in the garage and mate up with the gearbox, which had undergone modifications to the input shaft to carry a Rover clutch plate, and the transfer of the gear selector shaft to the opposite side of the box. The union was completed via a Rover to Renault adaptor plate and a hybrid clutch thrust bearing. At about this time I decided to visit the Tornado factory at Kidderminster and have a chat with proprietor Andy Sheldon, who kindly let me run a tape measure over a completed chassis to confirm future compatibility with my monocoque and a Tornado body kit, and also enable me to design the front and rear sub frames to carry bodywork, radiator, gearbox mount etc and

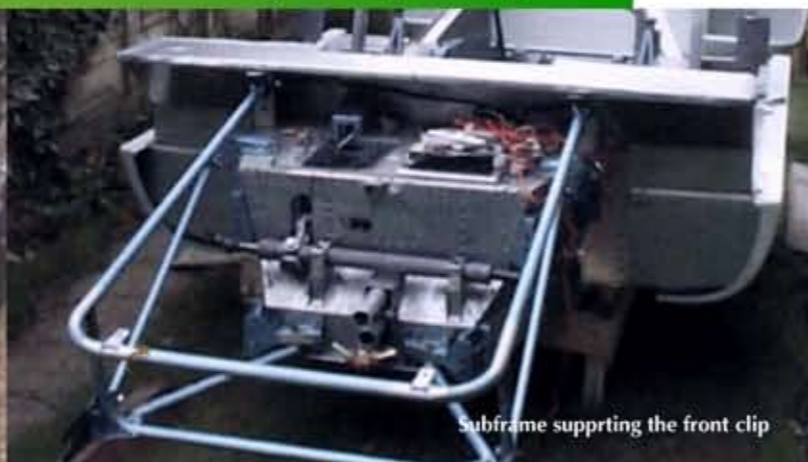
Subframe supporting the front clip

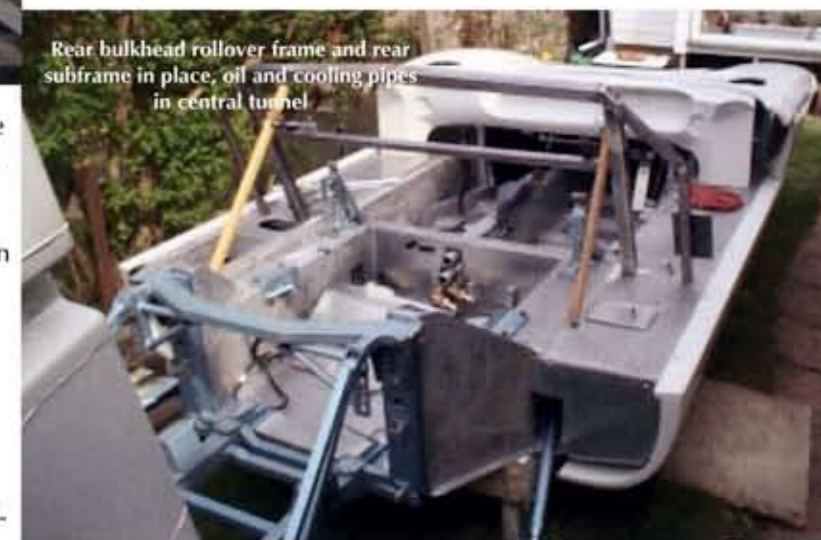
Rear bulkhead rollover frame and rear subframe in place, oil and cooling pipes in central tunnel

The next major job was to align and fix the Tornado mid bulkhead rollover support, which proved to be a fairly straight forward operation, being exactly compatible with the chassis for height. Brackets were welded to the bottom of the 2 main vertical members to align with fixings already provided in the tops of the main side members, and together with a pair of diagonal tubular braces from the top of the frame rearwards to the deck of the engine bay, also supported the front anchorages for the top rear radius arms. With the cockpit spider in place it was possible to make the profiles from alloy sheet for
